## Troubleshooting Dyness Batteries in Connection with GoodWe Inverter

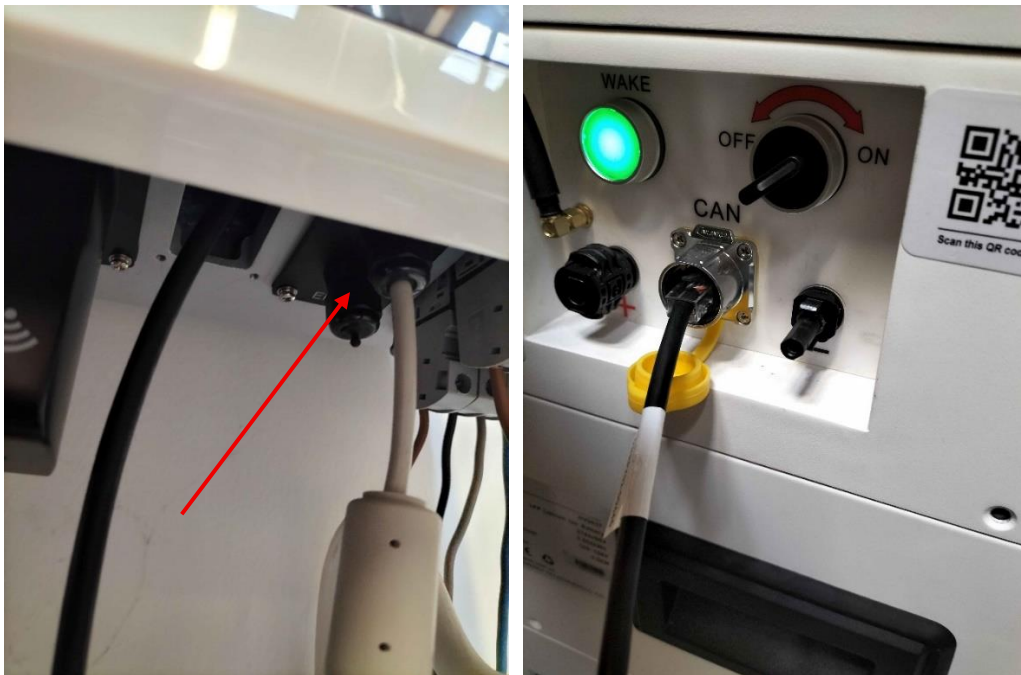
\*The inverter has an RJ45 socket at the factory-installed location.

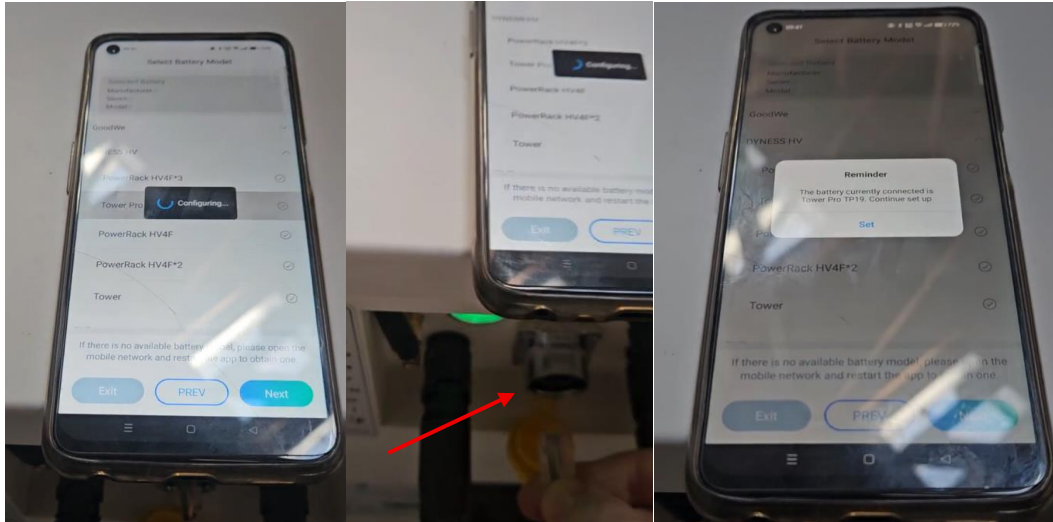
Select Tower PRO battery | Unplug and plug the connector | Device detection.

2. After powering on the energy storage and inverter, disconnect the communication cable from the Dyness control module, then reconnect it. It's best to do this during the configuration (Solar GO) by selecting the Dyness Tower PRO battery. The reset enables communication reset and device detection.

*\*Dyness units manufactured after 06.2022 have a baudrate of 500K. The correct setting for this battery is Dyness Pro. If the Dyness Tower variant is selected, disconnection may occur over time!*

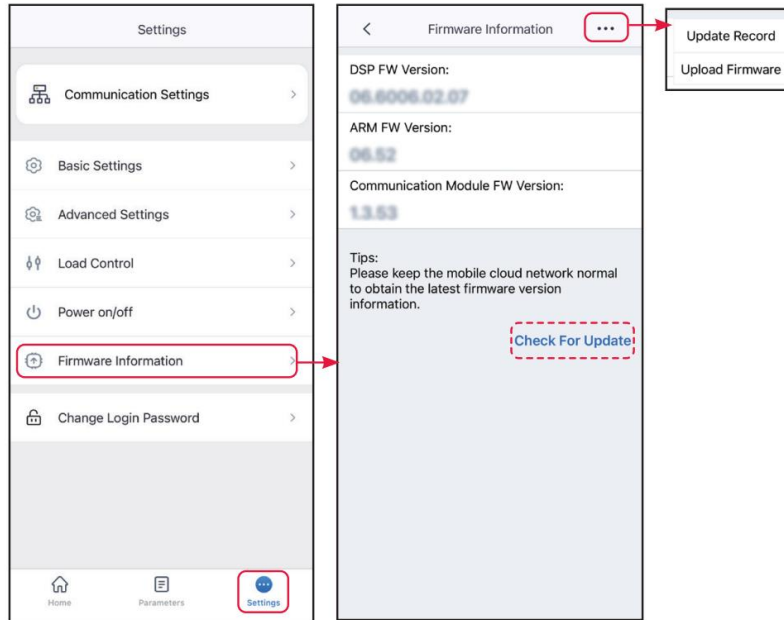
3. No communication between Dyness and GoodWe ET 20 (G2) may result from outdated firmware. The inverter requires at least ARM version 13 to detect the battery.

The update can be performed locally via the SolarGo app by connecting to the inverter. After the update, the ARM FW Version must be at least 13.
